# Thermal Remodeling Wasilla, Alaska

# Bowers Home Remodel Case #1

# Agate House Remodel Case #2

# Susitna Cottage Case #3

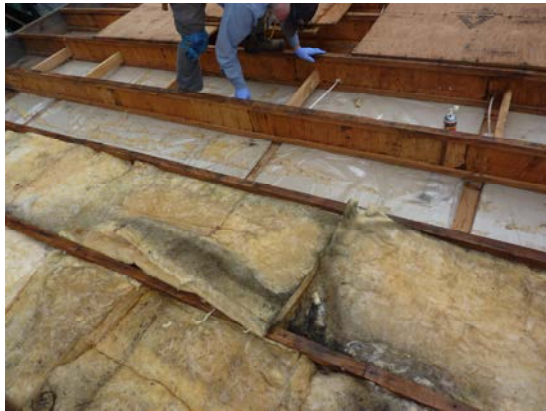
Dark area on fiberglass batts is dirt from air leakage

New radiant vapor barrier in bottom of joist bay  
All penetrations sealed with duct sealant
